# ASSESSMENT OF DOME BUILDING DAMAGE AND REPAIR METHOD

## Assessment of Dome Building Damage and Repair Method

To cite this article: Jonbi Jonbi 2018 *IOP Conf. Ser.: Mater. Sci. Eng.* **392** 062010

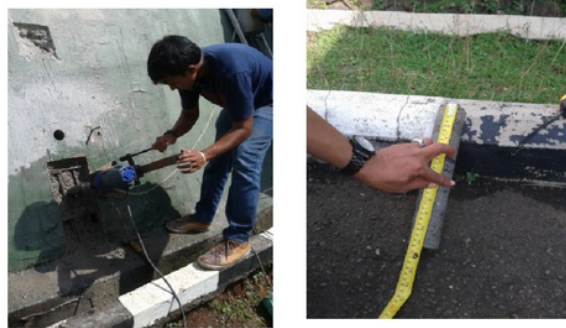
Figure 2: Core Drilling

Core drilling (Fig.2.) is intended for obtaining specimen out of existing concrete was before test in laboratory to find compression strength of concrete. The size of specimen cylinder is 200 mm height and 100 mm diameter. Coring is performed along the dome around 8 points with a height variation of 50 mm and 100 mm from the dome base.

The UPV test results show that the crack depth in the dome building is 65-100 mm. The crack depth of 65-100 mm occurred larger than the concrete cover is 50 mm. This indicates the cracks a structural crack. So it needs repair by injection with epoxy material. Based on 4 samples of coring tested press obtained concrete strength  $f'_c$  20 MPa

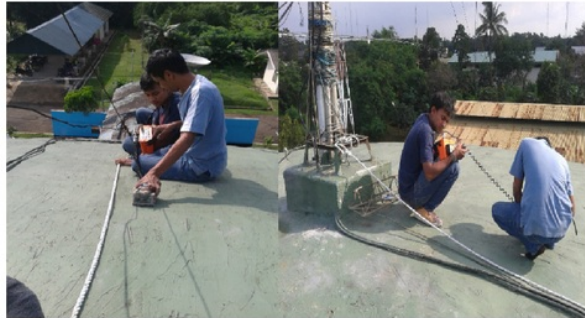
Figure 3: Profometer Testing

Profometer test is intended for inspecting the existing 14 mensions and spacing of the reinforcing bars. The testing was carried out at eight locations ranging from a height of 500 mm from the bottom to the top of the dome. See Fig. 3 as explanation. The results are Meridian reinforcing 2 D13 with 10 cm distance and 10 mm diameter longitudinal reinforcement with 30 cm distance.

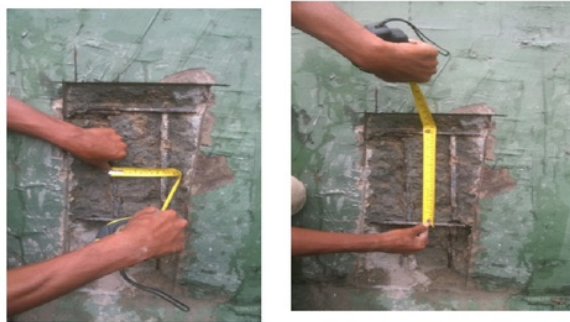
Figure 4: Destructive Test

Destructive test carried out was chipping of concrete so as to be able to inspect the size and spacing of reinforcing bars (Fig.4). The results were then compared to the ones obtained out of profometer test, which turned out to be the same result with the test results of the profometer.

The Destructive test results show that the meridian reinforcement is 13 mm in diameter while the longitudinal reinforcement diameter is 10 mm

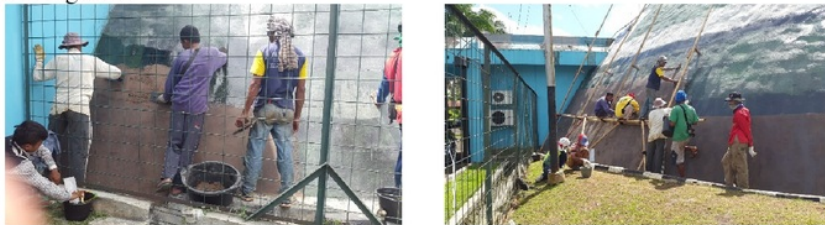
Figure 5: Instalment of CFRP to Strengthening Dome

Since inadequate reinforcing bars are embedded in the concrete, then it was not possible to insert additional reinforcing bars in the concrete. Another way to strengthening the hoop reinforcing bars was adopted. The method of repairment was to use carbon fibre reinforced plastic (CFRP). The need for CFRP material was computed as follows. The demand of CFRP usage on the lower area with height of  $0.629 \times 22\text{m} = 13.838\text{ m}$  is done as shown below. The total tension force is 1522.18 kN. the CFRP was needed is  $304\text{ mm}^2$  and reinforcement width required is 2.53 m.

Based on the safety factor, therefore, 3.8m was attached. The installment of the repairment is shown in Figure 5.

The repairment was carried out in two steps. First, the leakage problem was overcome by epoxy grout and epoxy mortar at problematic region of the dome. Secondly, the cracks at bottom portion of the dome was overcome by Injection with epoxy, then covering internal and external surfaces of bottom portion of the dome by carbon fibre reinforced plastic (CFRP). The region covered was from support until 3.8 meter height.
