Repair Methods and Applications to overcome Honeycomb, Cold Joint and Cracks in Concrete

Jonbi¹,

¹(Department of Civil Engineering, Faculty of Engineering, Universitas Pancasila, Jakarta, Indonesia).

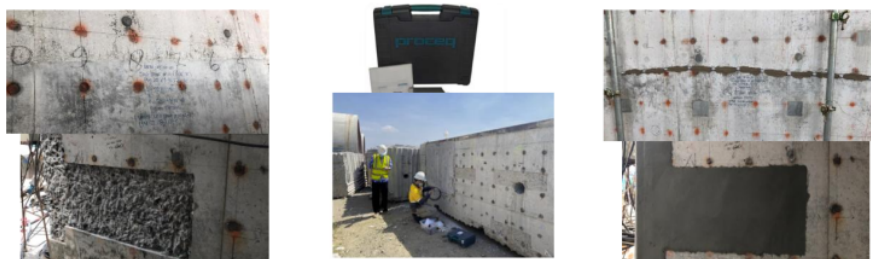
Figure 1. repair work control: before, testing and after work

Fourth stage : determine the repair method according to the type of damage that exists by referring to the standards issued by the american concrete institute [12-13]. Fifth stage : material selection for repair of structural concrete fillings. material is selected based on material from several manufacturers such as BASF, SIKA and FOSR, the basis for selection is mechanical properties, material availability and price. The procedure begins with identifying the cause of the damage and assessing the concrete substrate, and continues with evaluate the mechanical properties and durability of the selected [14-15]. The sixth step: the implementation of repair work in accordance with the methods and materials selected for the type of damage that exists. The seventh step is to control the results of the repair work. To check the success of the work, it is necessary to test the compressive strength of the grouting and patching materials. Additional testing for patching work is carried out with a bond strength test with a pull out test, then on the control concrete injection work in the form of a UPV test before and after the repair is carried out. As shown in Figure 1.

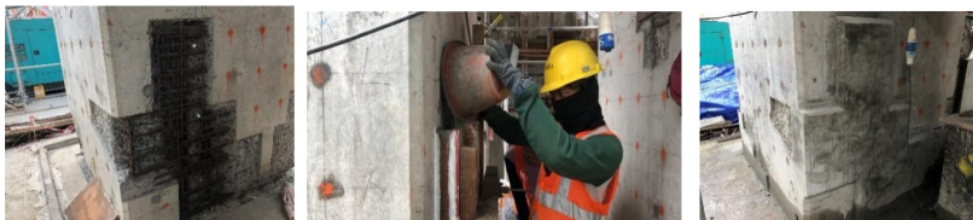
Type 2. Grouting Honeycomb from 50 mm up to 100 mm (Fig.3)

Figure 3. Honeycomb from 50 mm up to 100 mm

Repair method and application: chipping existing honeycomb, until it passes through reinforcement which is at least 10 mm. Chipping uses Hydraulics, to avoid damage to work. Chipping must be done by repair worker. Chipping is adjusted according to the existing damage zone. Install the shear connector every 250-400mm depending on the surface area to be grouted. Install formwork and attach strong and not leak. After everything is ready, Grouting can be done using a grout pump or pouring system by using for certain positions. Material shear connector is HILTI anchor HUS3-H Type

Material for Grouting: MasterFlow 880 is non-shrink, iron aggregate precision grout with high early and ultimate strength. It is typically placed at a flowable consistency at thickness between 10 mm and 150 mm. Technical properties: Compressive strength $>$ 90 MPa and Flexural strength $>$ 90 MPa after 28 days.

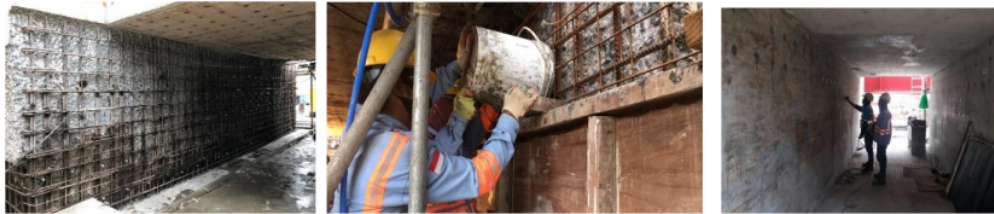
Type 3. Grouting and injection Deepest Honeycomb (Fig.4)

Figure 4. Large Honeycomb

Repair method and application : the injection packers inserted into pre-drilled holes shall be fixed at intervals along the length of each crack. Injection point drill depth is adjusted by internal honeycomb or at least 100 mm. The distance between each packer will depend upon the width and depth of the crack. Spacing shall be close enough to ensure that the resin will penetrate along the crack to the next point of injection. This will normally be between 100 mm and 200 mm. Before the grout work is carried out, the formwork installed must be strong, not leaky and use good materials to produce a flat concrete surface that is repaired. Masterflow 880 has good flow properties, so it can fill the deepest honeycomb. Meanwhile, to fill a small void, the injection pipe must be installed/ prepared, the pipe size is longer than the thick grouting. After everything is ready, installation work with Masterflow 880 can be done using a grout pump, then after 1 x 24 hours, injection work with epoxy to fill a small vacuum can be do Material for Grouting: MasterFlow 880 is non-shrink, iron aggregate precision grout with high early and ultimate strength. It is typically placed at a flowable consistency at thickness between 10 mm and 150 mm. Technical properties: Compressive strength > 90 MPa and Flexural strength > 90 MPa after 28 days. Material for injection : Conbextra EP10TG epoxy is a two part, solvent-less, low viscosity, non-shrink epoxy resin system that forms permanent bond and seal in cracks in concrete. Crack widths between 0.25 mm - 7 mm can be treated. This epoxy is designed to be injected into cracks using suitable resin injection equipment. The injection pressure should be at least 0.4 N/mm² (4 Bar). Technical data : Compressive strength 7 days : 83 N/mm² , flexural strength : 63 N/mm²

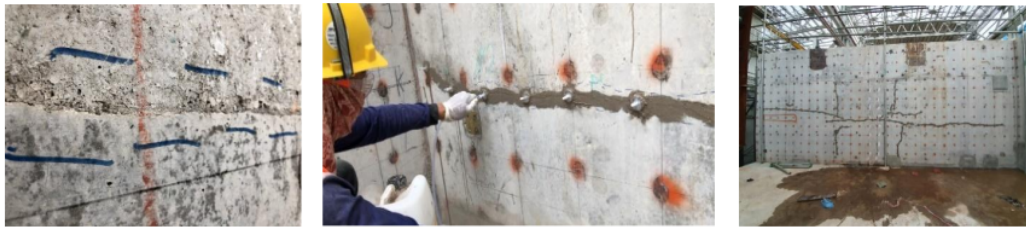
Type 4. Injection with Epoxy to repair cold joint and cracks(Fig. 5)

Figure 5. Repair work cold joint and cracks

Repair method and application : injection point nipple is affixed along the crack using epoxy sealing, which must be installed at intervals along the length of each crack. The distance between each packer will depend upon the width and depth of the crack. Spacing shall be close enough to ensure that the resin will penetrate along the crack to the next point of injection. This will normally be between 100 mm and 200mm.

Material for injection: Conbextra EP10TG epoxy is a two part, solvent-less, low viscosity, non-shrink epoxy resin system that forms permanent bond and seal in cracks in concrete. Crack widths between 0.25 mm - 7 mm can be treated. This epoxy is designed to be injected into cracks using suitable resin injection equipment. The injection pressure should be at least 0.4 N/mm² (4 Bar). Technical data : Compressive strength 7 days : 83N/mm² , flexural strength : 63 N/mm²

Epoxy injection work, if carried out with the correct repair method, has been proven to be able to overcome the problem of cold joints and cracks, this is in line with research conducted by several researchers [16].

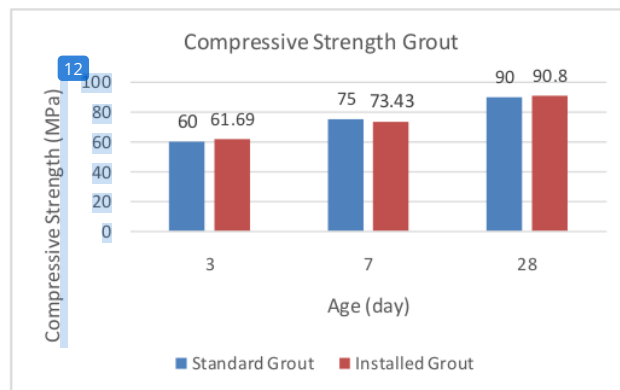
The results of the grouting material test that have been applied in the field and the grout standard from the producer show significant results as shown in Figure 6. The standard grout from the producer for 3 days > 60 MPa, 7 days > 75 MPa and 28 days > 90 MPa. Then the results of field tests for 3, 7, 28 days were 61.69 MPa, 73.43 MPa and 90.8 MPa. Thus, it can be ascertained that the grout material used is in accordance with the existing quality.

Figure 6. Compressive strength Grout

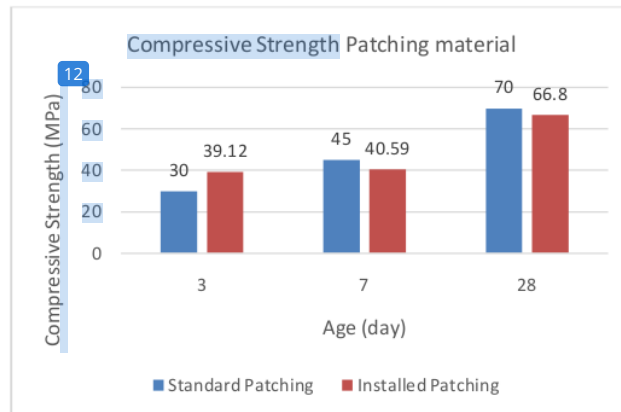
The results of the patching material test that have been applied in the field and the grout standard from the producer show significant results as shown in Figure 7. The standard patching material from the producer for 3 days > 30 MPa, 7 days > 45 MPa and 28 days > 70 MPa. Then the results of field tests for 3, 7, 28 days were 39.12 MPa, 40.59 MPa and 66.8 MPa. These results show the results of the compressive strength in the field reaching 95.4%, this is due to the weather conditions during application repair in the field, but these results are still acceptable

Figure 7. Compressive strength patching material
